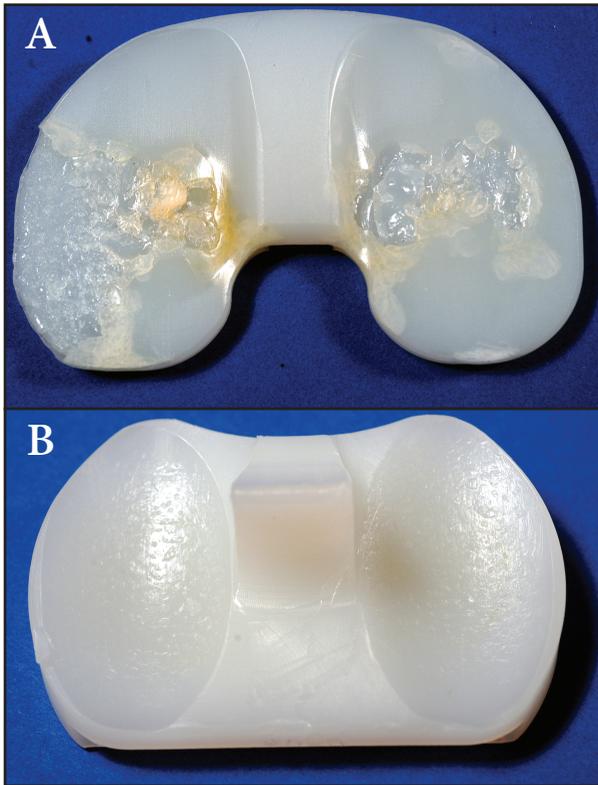
Figure 13-3. (A) Severe delamination and (B) pitting modes of damage.
