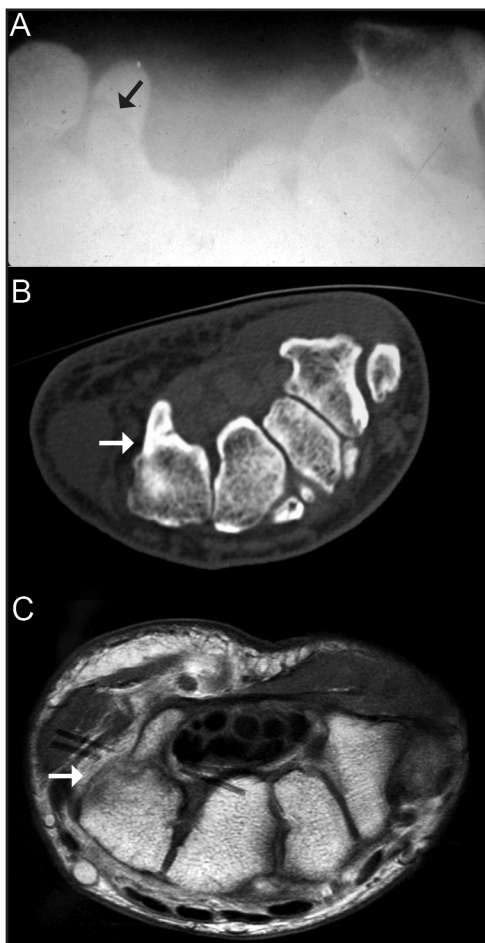
Figure 11-2. Radiograph (A), axial CT scan image (B), and axial MRI image (C) of 3 different patients with hamate hook fractures. The carpal tunnel radiograph is the first-line diagnostic study if this fracture is suspected. The CT scan can be performed if the carpal tunnel view does not show a fracture but suspicion is high. MRI generally is not used for this, but this patient underwent MRI for “wrist pain” and was found to have this hamate hook nonunion.
