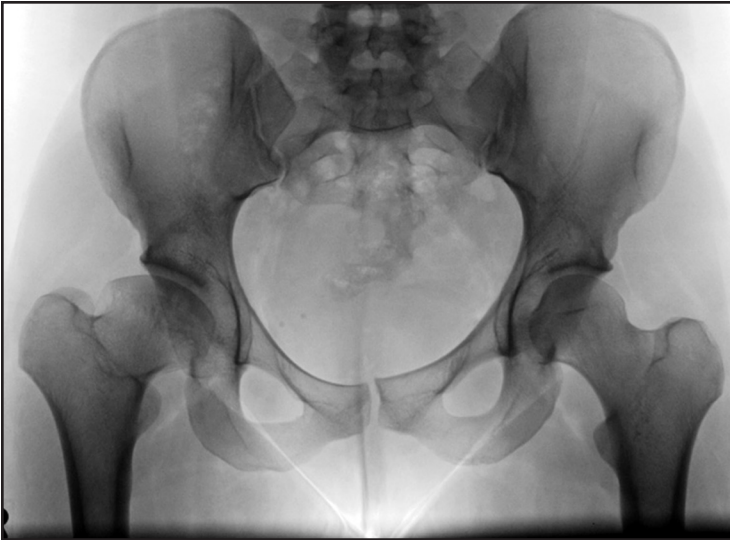
Figure 11-4. Preoperative radiograph of a 22-year-old woman with a dysplastic right hip and Perthes-like deformity of her right hip.
