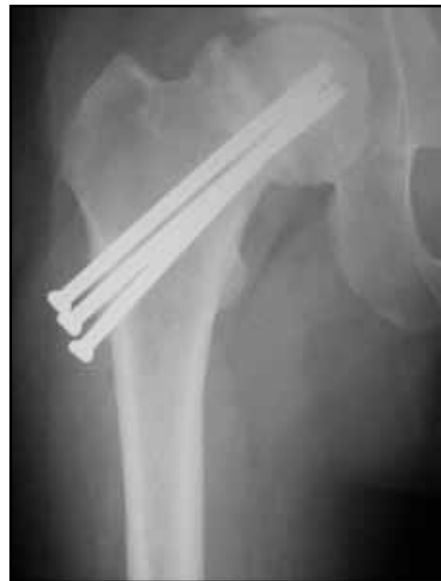
**Figure 21-1.** An AP radiograph demonstrating a displaced, vertically oriented femoral neck fracture with a nonanatomic reduction and less than ideal hardware placement. This resulted in a failure of fixation with varus collapse and inferior translation. Ultimately, a femoral neck nonunion was the outcome.
